**Flood Control Project Maintenance  
Levee Inspections**

## Maintenance Issue Types Only, Levee Inspection Report By Mile - Spring 2017

### Levee District No. 0002 (Glenn County)

Waterway	Bank	Unit Miles	Inspection Start/End	Inspector
Unit No. 01 Glenn County Sacramento River	Right	4.90	03/29/2017 03/29/2017	Bob Duffey

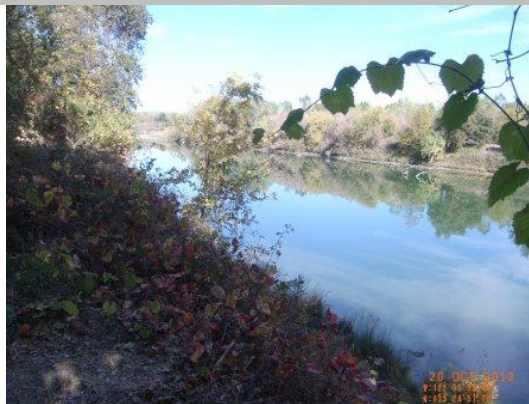
Photo 1 of 2 : SP\_2017\_LD0002\_28\_6\_20170315\_00003.jpg

LM Start	0.07	Rating **	M	Issue No.	6
LM End	0.28	Issue Type +	Ma	Location *	WS
Category	Supplemental			GPS Latitude/Longitude	
				Start	End
Item	2015 USACE Erosion Survey, DRAFT			39.414649 °	39.417689 °
				-122.009853 °	-122.010369 °
DWR ID	DWR_LD0002_01_s_2016_6				
Comment Code					
Inspector Comment					
2009 - Very slow retreat, hard toe, encroaching into the levee projection. 2010 - Slowly eroding. 2011 - Site extended downstream. 2015: Last observed in 2013. [2015 Site ID: SAC_164-7_R]

USACE 2013 Photo #1

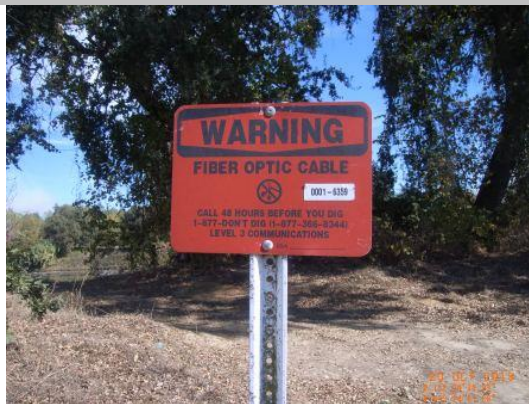
Photo 2 of 2 : SP\_2017\_LD0002\_28\_6\_20170315\_00004.jpg

USACE 2013 Photo #2

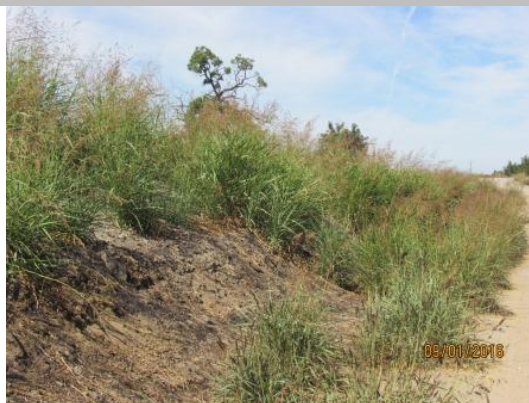
Photo 1 of 1 : SP\_2017\_LD0002\_28\_32\_20170315\_00015.jpg

LM Start	0.54	Rating **	M	Issue No.	32
LM End	0.59	Issue Type +	Ma	Location *	WS
Category	Earthen Levee			GPS Latitude/Longitude	
				Start	End
Item	Vegetation			39.421335 °	39.422073 °
				-122.011389 °	-122.011449 °
DWR ID	DWR_LD0002_01_f_2016_32				
Comment Code					
V1 : Control annual grass and weeds on the levee slopes and easements.					
Inspector Comment

View of the waterside vegetation looking upstream.

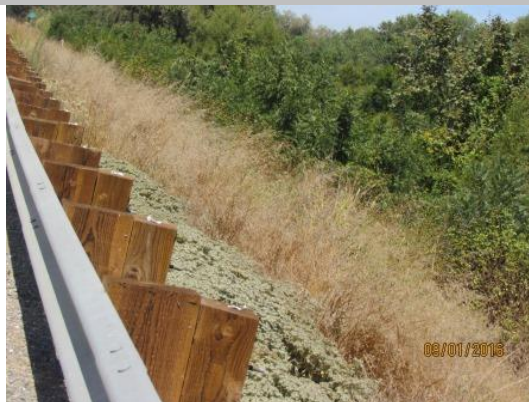
Photo 1 of 1 : SP\_2017\_LD0002\_28\_33\_20170315\_00016.jpg

LM Start	0.69	Rating **	M	Issue No.	33
LM End	0.80	Issue Type +	Ma	Location *	WS
Category	Earthen Levee			GPS Latitude/Longitude	
				Start	End
Item	Vegetation			39.423464 °	39.425054 °
				-122.011640 °	-122.011451 °
DWR ID	DWR_LD0002_01_f_2016_33				
Comment Code					
V1 : Control annual grass and weeds on the levee slopes and easements.					
Inspector Comment

View of the waterside vegetation looking upstream.

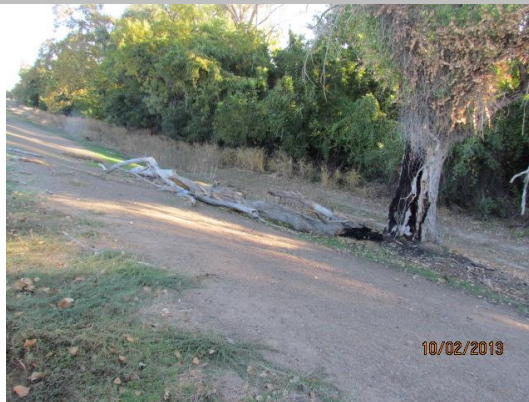
Photo 1 of 2 : SP\_2017\_LD0002\_28\_40\_20170315\_00019.jpg

LM Start	1.24	Rating **	M	Issue No.	40
LM End	1.24	Issue Type +	Ma	Location *	WS
Category	Earthen Levee			GPS Latitude/Longitude	
				Start	End
Item	Encroachments			39.431499 °	39.431499 °
				-122.010803 °	-122.010803 °
DWR ID	DWR_LD0002_01_f_2013_40				
Comment Code					
TR : Tree or limb					
Inspector Comment					
Remove the tree limbs from the waterside slope.

View of the downed tree limb along the slope of the levee.

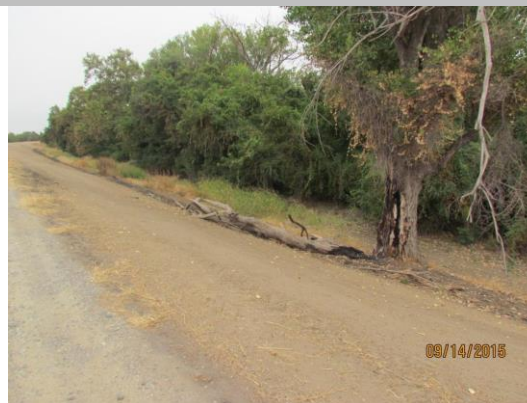
Photo 2 of 2 : SP\_2017\_LD0002\_28\_40\_20170315\_00020.jpg

LM Start	1.24	Rating **	M	Issue No.	40 (cont)	
LM End	1.24	Issue Type +	Ma	Location *	WS	
Category	Earthen Levee			GPS Latitude/Longitude		
				Start		End
Item	Encroachments			39.431499 °		39.431499 °
				-122.010803 °		-122.010803 °
DWR ID	DWR_LD0002_01_f_2013_40					
Comment Code						
TR : Tree or limb						
Inspector Comment						
Remove the tree limbs from the waterside slope.

View of the tree limbs along the waterside slope.

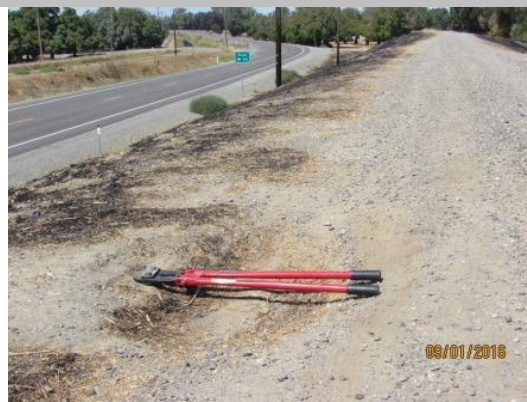
Photo 1 of 1 : SP\_2017\_LD0002\_28\_34\_20170315\_00017.jpg

LM Start	1.40	Rating **	M	Issue No.	34
LM End	1.40	Issue Type +	Ma	Location *	CR
Category	Earthen Levee			GPS Latitude/Longitude	
				Start	End
Item	Crown Surface / Depressions / Rutting			39.433809 °	39.433809 °
				-122.010814 °	-122.010814 °
DWR ID	DWR_LD0002_01_f_2016_34				
Comment Code					
C2 : Repair depressions or ruts in the crown or slope.					
Inspector Comment

View of a depression on the levee crown looking upstream.

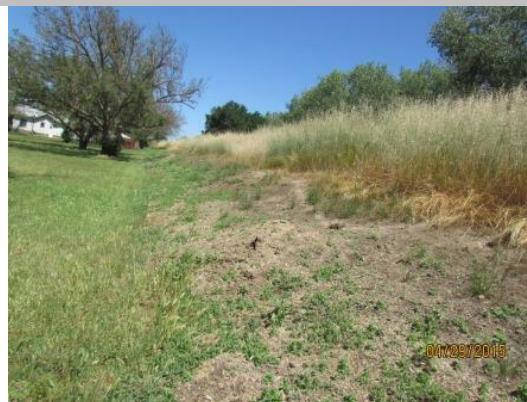
Photo 1 of 2 : SP\_2017\_LD0002\_28\_15\_20170315\_00008.jpg

LM Start	1.52	Rating **	M	Issue No.	15
LM End	1.60	Issue Type +	Ma	Location *	LS
Category	Earthen Levee			GPS Latitude/Longitude	
				Start	End
Item	Animal Control			39.435485 °	39.436643 °
				-122.010640 °	-122.010498 °
DWR ID	DWR_LD0002_01_f_2012_15				
Comment Code					
A3 : No rodents visible, but rodent burrows visible; need to backfill and compact or grout burrows.					
Inspector Comment					
LMA needs to repair the rodent holes.

View of the rodent holes along the landside slope.

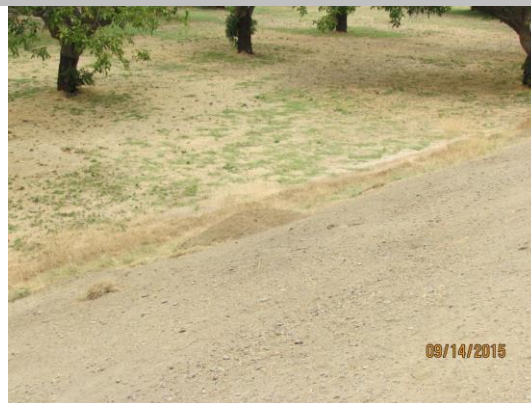
Photo 2 of 2 : SP\_2017\_LD0002\_28\_15\_20170315\_00009.jpg

LM Start	1.52	Rating **	M	Issue No.	15 (cont)	
LM End	1.60	Issue Type +	Ma	Location *	LS	
Category	Earthen Levee			GPS Latitude/Longitude		
				Start		End
Item	Animal Control			39.435485 °		39.436643 °
				-122.010640 °		-122.010498 °
DWR ID	DWR_LD0002_01_f_2012_15					
Comment Code						
A3 : No rodents visible, but rodent burrows visible; need to backfill and compact or grout burrows.						
Inspector Comment						
LMA needs to repair the rodent holes.

View of the rodent holes along the landside slope.

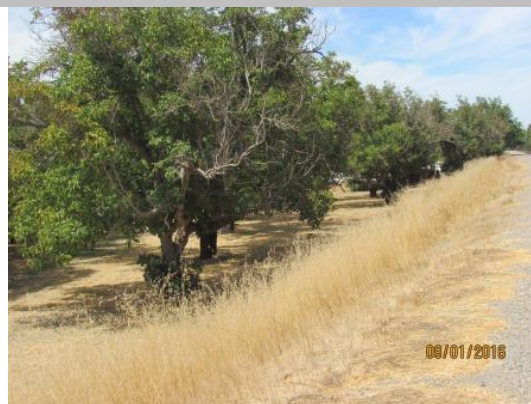
Photo 1 of 1 : SP\_2017\_LD0002\_28\_35\_20170315\_00018.jpg

LM Start	1.52	Rating **	M	Issue No.	35
LM End	1.65	Issue Type +	Ma	Location *	LS
Category	Earthen Levee			GPS Latitude/Longitude	
				Start	End
Item	Vegetation			39.435522 °	39.437441 °
				-122.010582 °	-122.010438 °
DWR ID	DWR_LD0002_01_f_2016_35				
Comment Code					
V1 : Control annual grass and weeds on the levee slopes and easements.					
Inspector Comment

View of the landside vegetation looking upstream.

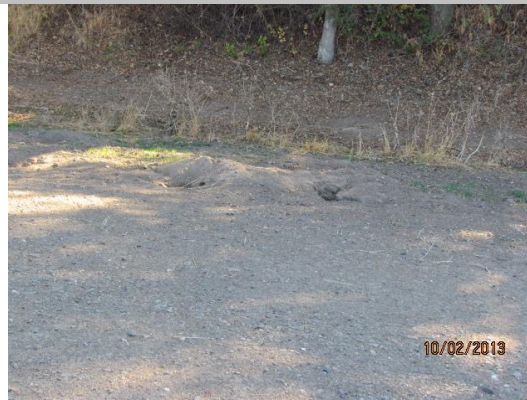
Photo 1 of 1 : SP\_2017\_LD0002\_28\_42\_20170315\_00021.jpg

LM Start	2.77	Rating **	M	Issue No.	42
LM End	2.77	Issue Type +	Ma	Location *	WS
Category	Earthen Levee			GPS Latitude/Longitude	
				Start	End
Item	Animal Control			39.451841 °	39.451841 °
				-122.017120 °	-122.017120 °
DWR ID	DWR_LD0002_01_f_2013_42				
Comment Code					
A3 : No rodents visible, but rodent burrows visible; need to backfill and compact or grout burrows.					
Inspector Comment

View of the rodent holes along the slope of the levee.

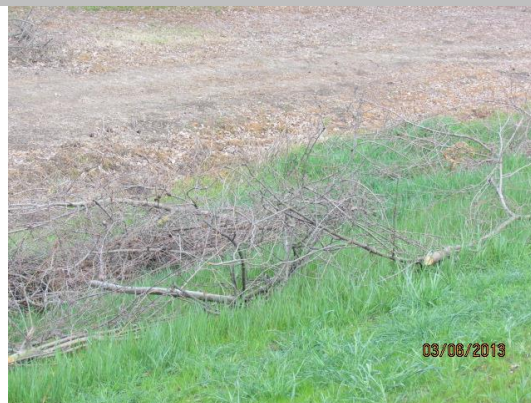
Photo 1 of 1 : SP\_2017\_LD0002\_28\_5\_20170315\_00002.jpg

LM Start	2.89	Rating **	M	Issue No.	5
LM End	2.89	Issue Type +	Ma	Location *	LS
Category	Earthen Levee			GPS Latitude/Longitude	
				Start	End
Item	Encroachments			39.453490 °	39.453490 °
				-122.016457 °	-122.016457 °
DWR ID	DWR_LD0002_01_f_2015_5				
Comment Code					
PR : Prunings					
Inspector Comment

View of the prunings along the landside toe.

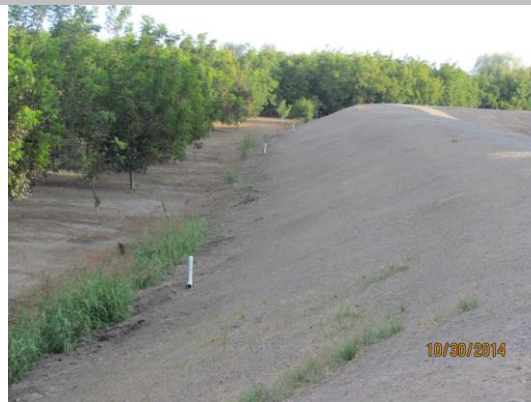
Photo 1 of 1 : SP\_2017\_LD0002\_28\_2\_20170315\_00001.jpg

LM Start	2.91	Rating **	M	Issue No.	2
LM End	2.96	Issue Type +	Ma	Location *	LS
Category	Earthen Levee			GPS Latitude/Longitude	
				Start	End
Item	Animal Control			39.453595 °	39.454003 °
				-122.016273 °	-122.015503 °
DWR ID	DWR_LD0002_01_f_2015_2				
Comment Code					
A3 : No rodents visible, but rodent burrows visible; need to backfill and compact or grout burrows.					
Inspector Comment

View of the rodent holes and bait station along the landside slope.

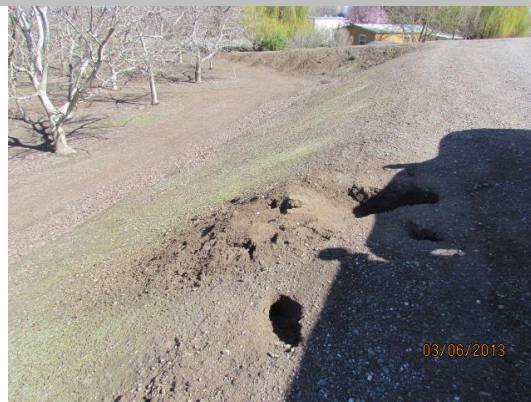
Photo 1 of 1 : SP\_2017\_LD0002\_28\_12\_20170315\_00006.jpg

LM Start	3.16	Rating **	U	Issue No.	12
LM End	3.16	Issue Type +	Ma	Location *	LS
Category	Earthen Levee			GPS Latitude/Longitude	
				Start	End
Item	Animal Control			39.456004 °	39.456004 °
				-122.012776 °	-122.012776 °
DWR ID	DWR_LD0002_01_s_2013_12				
Comment Code					
A1 : Exterminate rodents and backfill and compact or grout burrows.					
Inspector Comment					
Repair the rodent holes along landside slope.

View of the rodent activity along the landside slope.

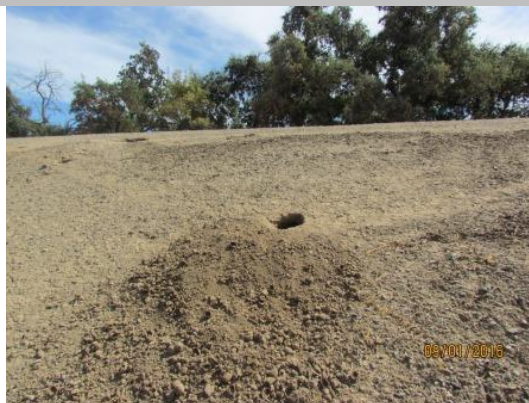
Photo 1 of 2 : SP\_2017\_LD0002\_28\_16\_20170315\_00010.jpg

LM Start	3.23	Rating **	M	Issue No.	16
LM End	3.30	Issue Type +	Ma	Location *	LS
Category	Earthen Levee			GPS Latitude/Longitude	
				Start	End
Item	Animal Control			39.456192 °	39.456272 °
				-122.011445 °	-122.010163 °
DWR ID	DWR_LD0002_01_f_2012_16				
Comment Code					
A3 : No rodents visible, but rodent burrows visible; need to backfill and compact or grout burrows.					
Inspector Comment					
Grout or fill the rodent holes.

View of the rodent holes along the landside slope.

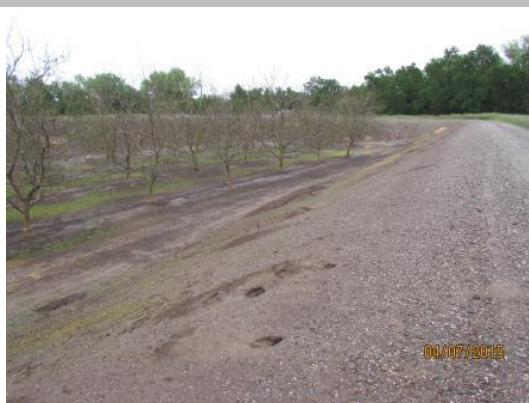
Photo 2 of 2 : SP\_2017\_LD0002\_28\_16\_20170315\_00011.jpg

View of the rodent holes along the landside slope.

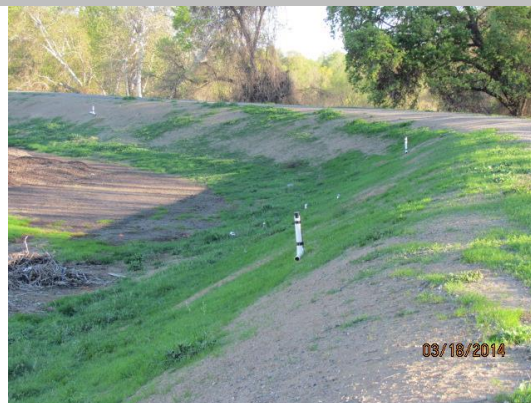
Photo 1 of 2 : SP\_2017\_LD0002\_28\_27\_20170315\_00012.jpg

LM Start	3.44	Rating **	U	Issue No.	27
LM End	3.52	Issue Type +	Ma	Location *	LS
Category	Earthen Levee			GPS Latitude/Longitude	
				Start	End
Item	Animal Control			39.457692 °	39.458705 °
				-122.009517 °	-122.009872 °
DWR ID	DWR_LD0002_01_s_2014_27				
Comment Code					
A3 : No rodents visible, but rodent burrows visible; need to backfill and compact or grout burrows.					
Inspector Comment					
Repair the rodent holes on landside slope.

View of the rodent activity along the landside slope.

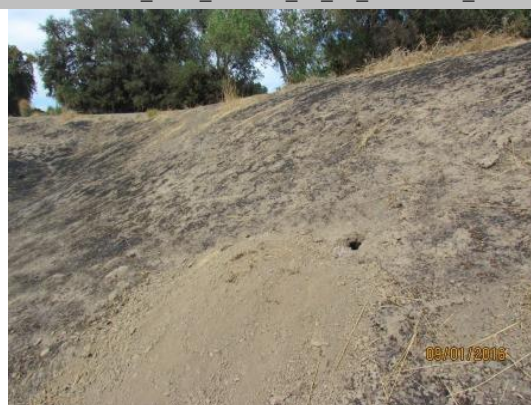
Photo 2 of 2 : SP\_2017\_LD0002\_28\_27\_20170315\_00013.jpg

View of the rodent holes along the landside slope.

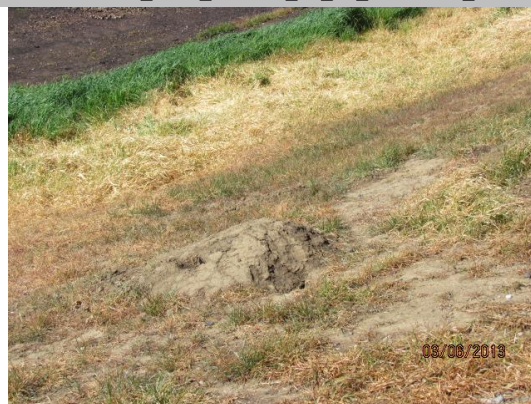
Photo 1 of 1 : SP\_2017\_LD0002\_28\_13\_20170315\_00007.jpg

LM Start	3.53	Rating **	U	Issue No.	13
LM End	3.57	Issue Type +	Ma	Location *	LS
Category	Earthen Levee			GPS Latitude/Longitude	
				Start	End
Item	Animal Control			39.458803 °	39.459305 °
				-122.009980 °	-122.010511 °
DWR ID	DWR_LD0002_01_s_2013_13				
Comment Code					
A3 : No rodents visible, but rodent burrows visible; need to backfill and compact or grout burrows.					
Inspector Comment

View of the rodent activity along the landside slope.

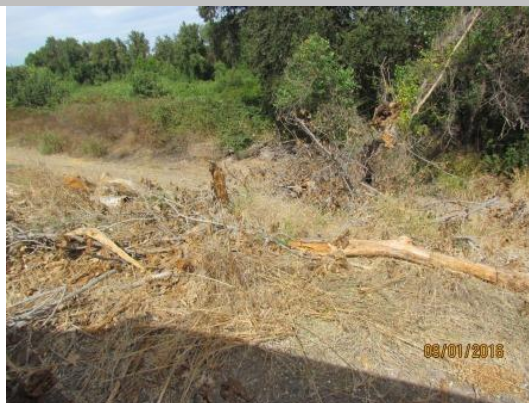
Photo 1 of 2 : SP\_2017\_LD0002\_28\_46\_20170315\_00022.jpg

LM Start	3.60	Rating **	M	Issue No.	46
LM End	3.60	Issue Type +	Ma	Location *	WS
Category	Earthen Levee			GPS Latitude/Longitude	
				Start	End
Item	Encroachments			39.459678 °	39.459678 °
				-122.010785 °	-122.010785 °
DWR ID	DWR_LD0002_01_f_2016_46				
Comment Code					
PR : Prunings					
Inspector Comment					
Remove the tree from the waterside slope and toe.

View of a fallen tree along the waterside slope.

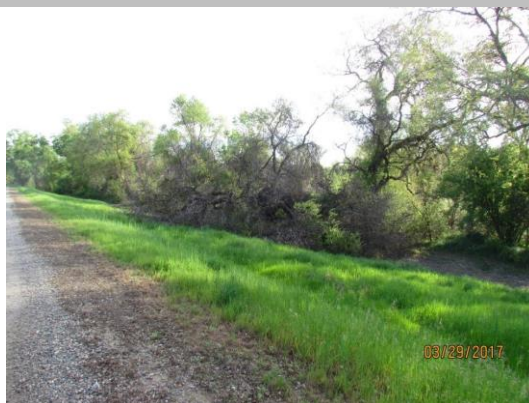
Photo 2 of 2 : SP\_2017\_LD0002\_28\_46\_20170330\_00055.jpg

View of the tree along the waterside slope and toe.

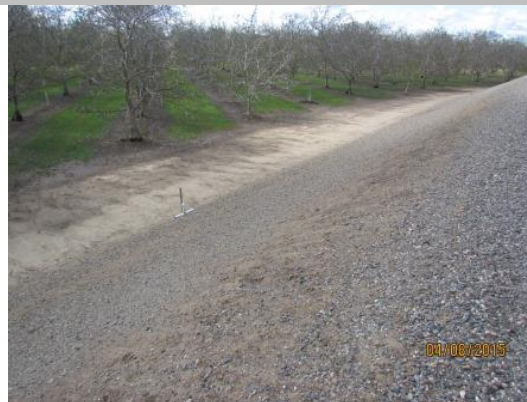
Photo 1 of 1 : SP\_2017\_LD0002\_28\_11\_20170315\_00005.jpg

LM Start	4.87	Rating **	A/W	Issue No.	11
LM End	4.87	Issue Type +	Ma	Location *	LS
Category	Earthen Levee			GPS Latitude/Longitude	
				Start	End
Item	Animal Control			39.476676 °	39.476676 °
				-122.017439 °	-122.017439 °
DWR ID	DWR_LD0002_01_s_2012_11				
Comment Code					
A3 : No rodents visible, but rodent burrows visible; need to backfill and compact or grout burrows.					
Inspector Comment					
The rodent holes have been filled with dirt.

View of the removed rodent holes and bait station.
